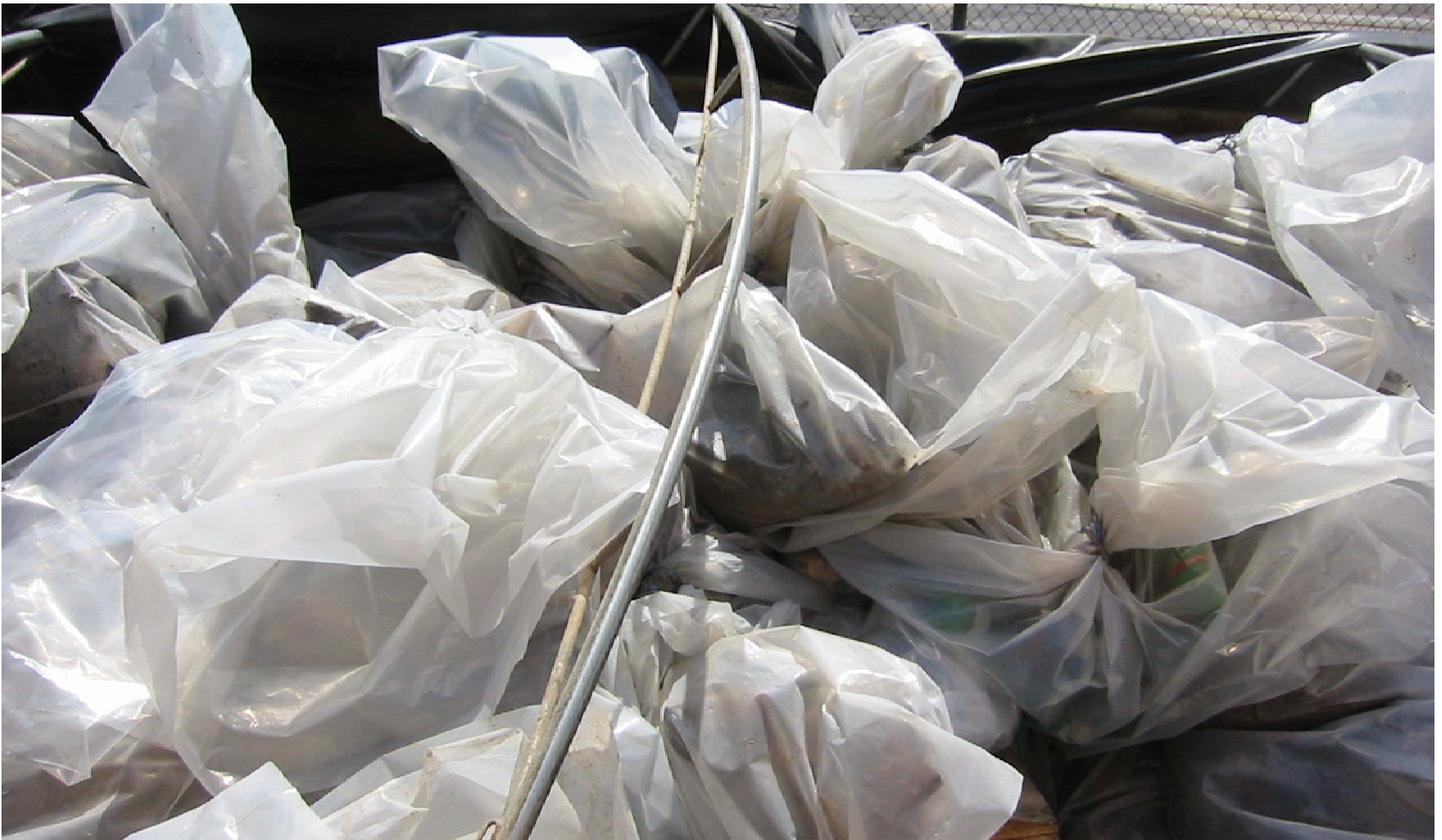
Photograph 21. Building 105 SAFR. Hazardous waste in small pieces (wood, metal, and plastic debris) placed in plastic bags then placed in Hazardous waste roll-off, September 2002.

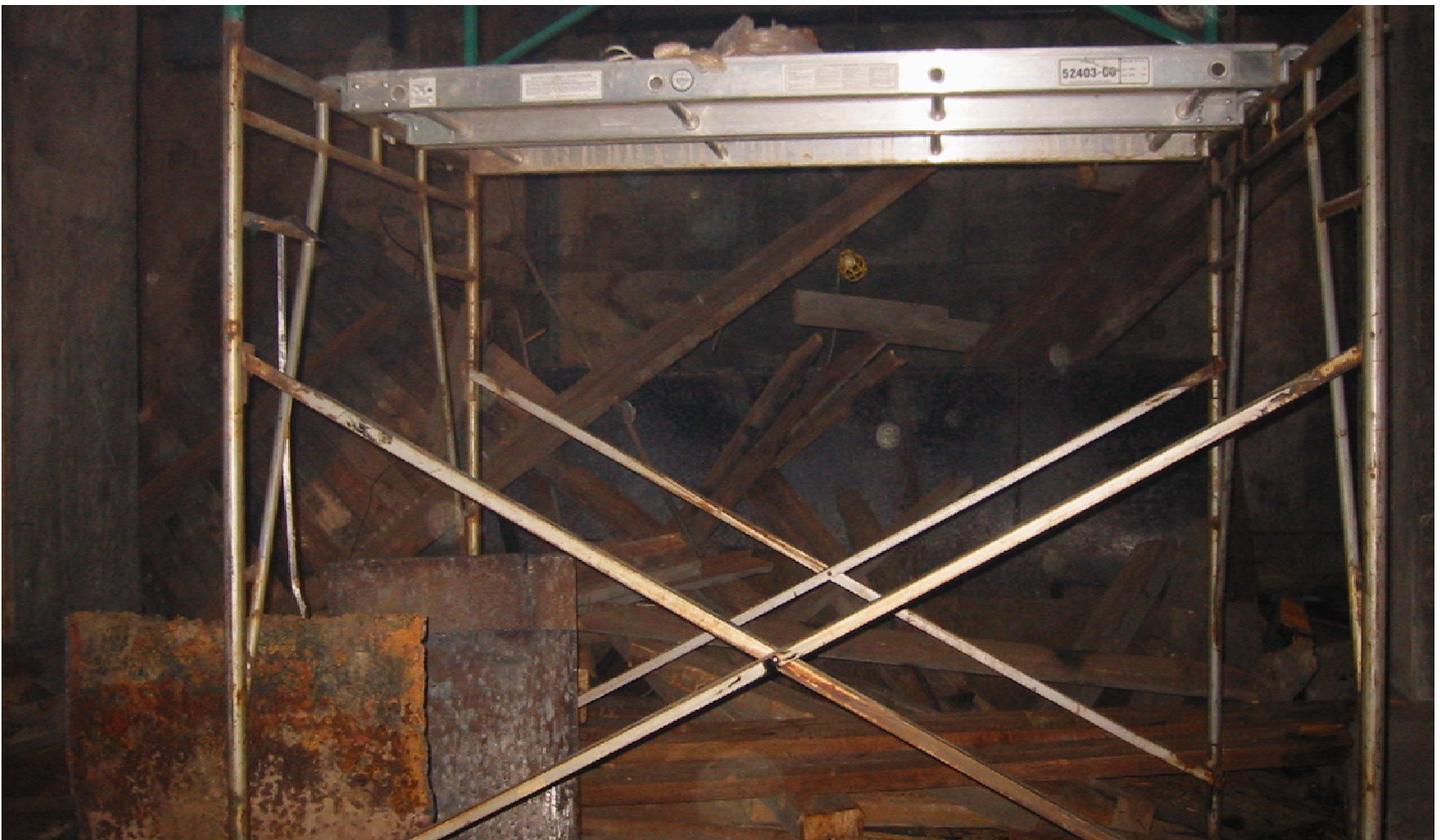
Photograph 22. Building 105 SAFR. Typical scaffolding erected to allow access to elevated range areas, September 2002.

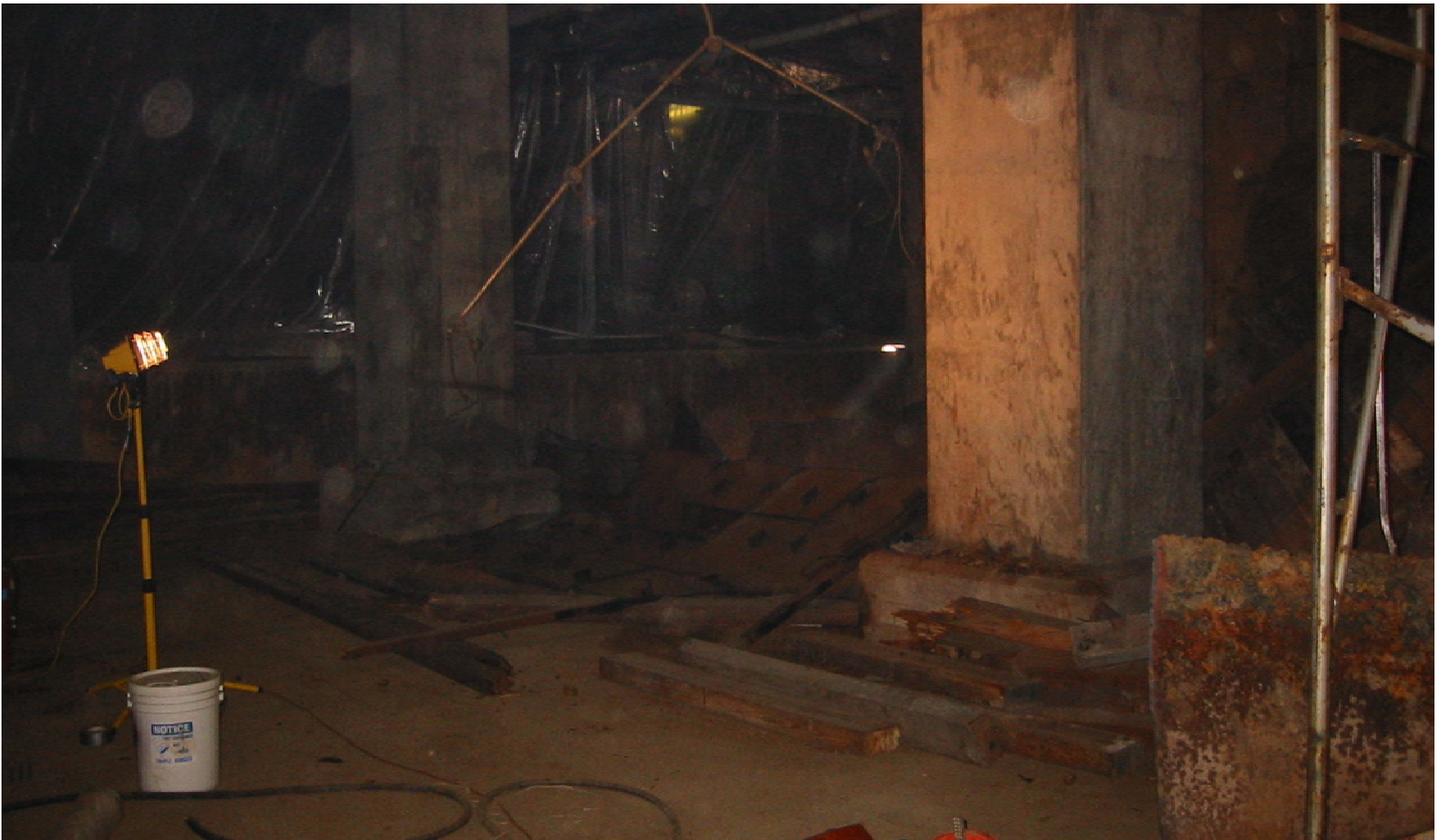
Photograph 23. Building 105 SAFR. Inside containment area; demolition of wood framing, September 2002.

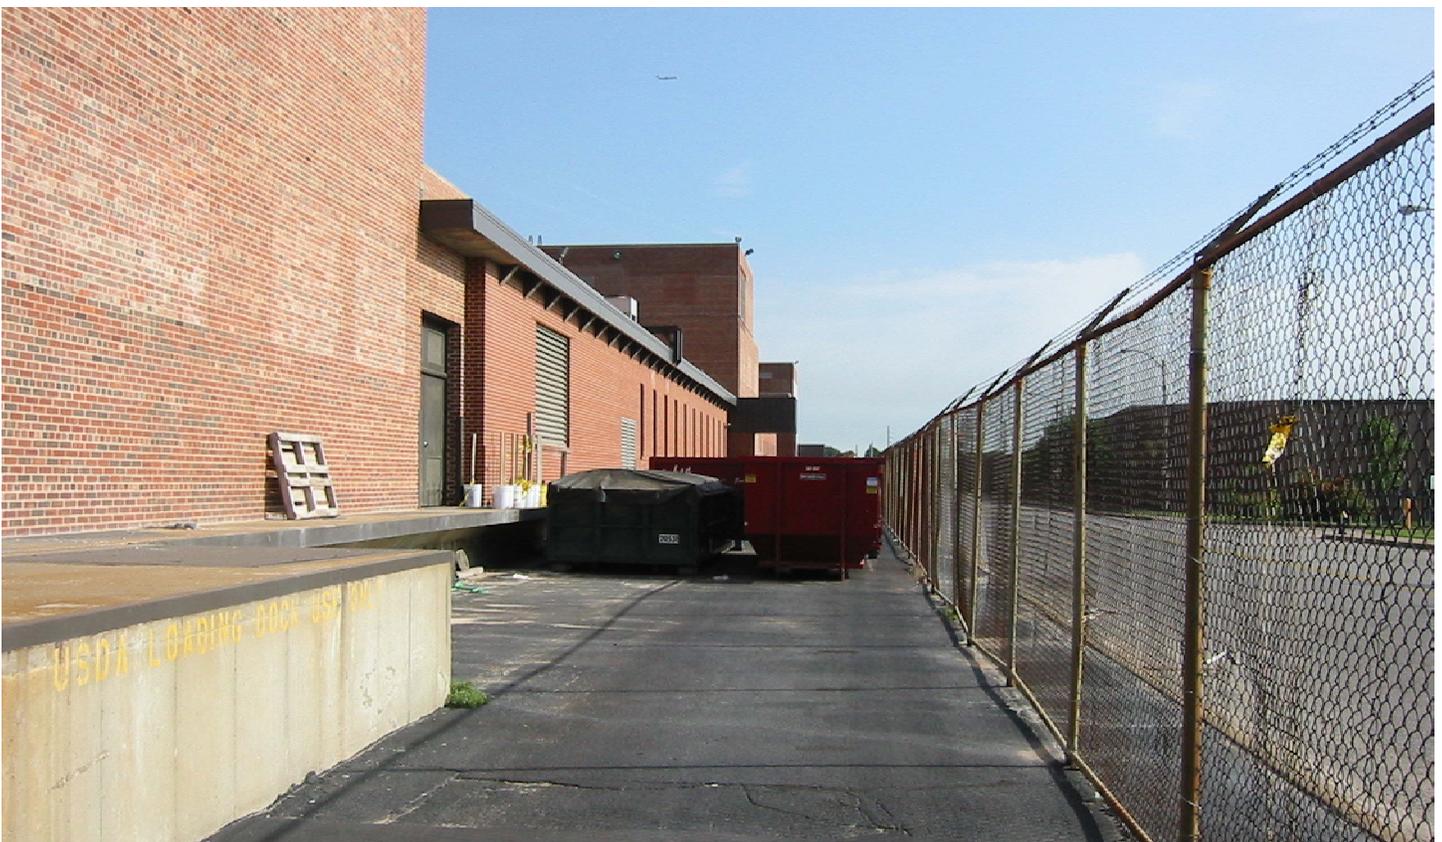
Photograph 24. Building 105 SAFR. Narrow access drive east side of building, September 2002.

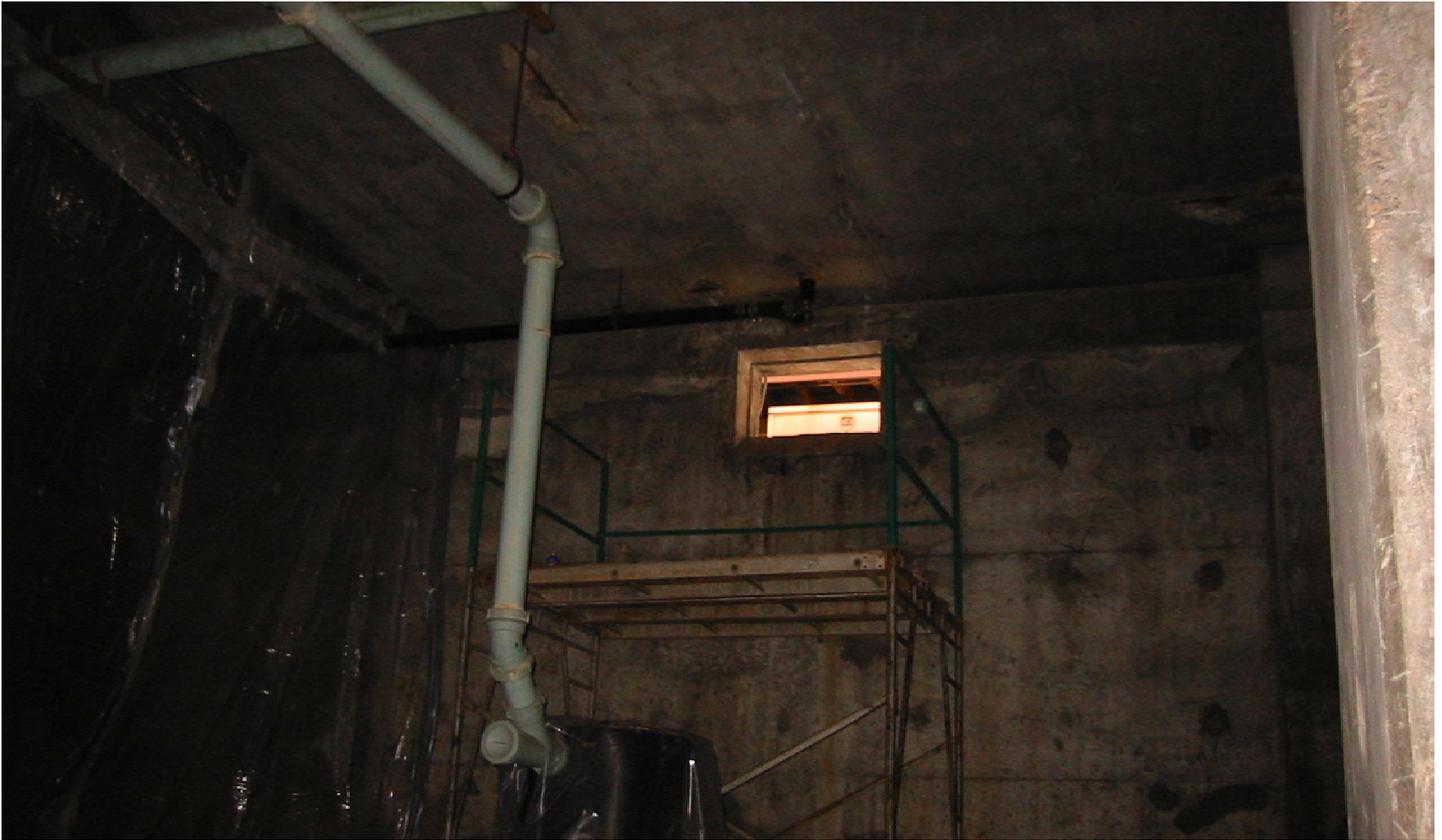
Photograph 17. Building 105 SAFR. Sewer sump in foreground; above at rear is ventilation window used to remove waste from basement, September 2002.

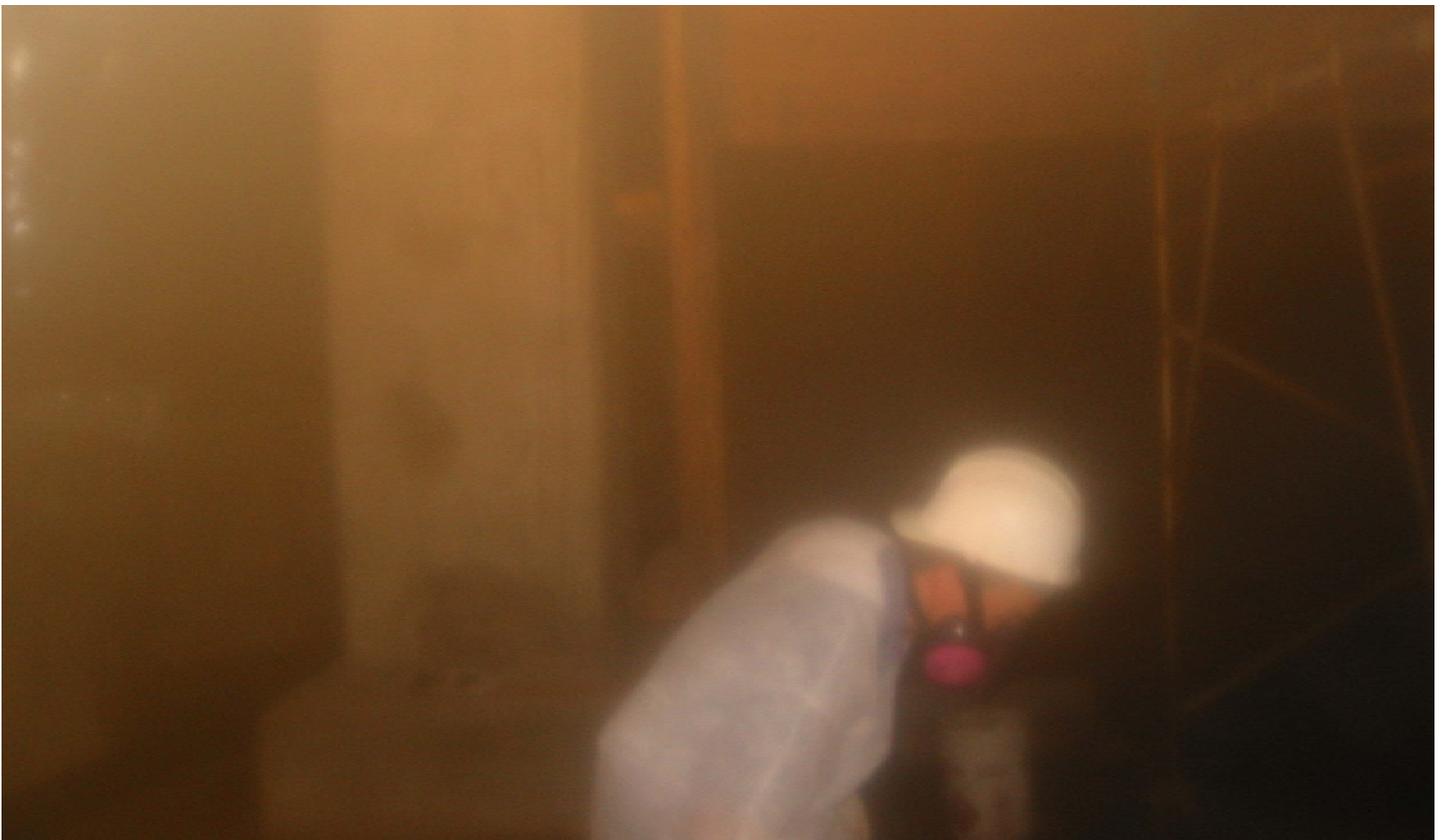
Photograph 18. Building 105 SAFR. Demolition worker in PPE, September 2002.
